Inspection Report

Sentinel Home Inspections, LLC

PROPERTY INSPECTION REPORT FORM

11/2/2022
Name of Client	Date of Inspection

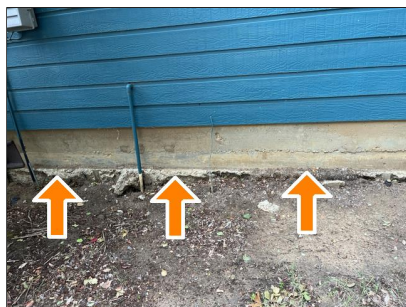
A. Item 1 Perimeter beam, left side (facing front)

(1) Perimeter beam is exposed in one or more areas of foundation. I recommend raising soil level to prevent deterioration and further erosion.

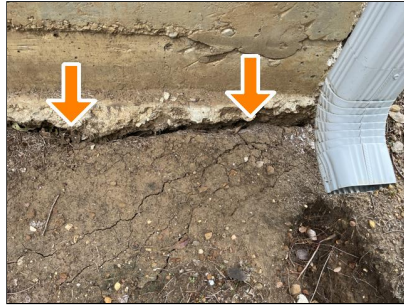
A. Item 3 Foundation, soil separation

(2) Note from Inspector: The soil has pulled away / separated from the foundation. This indicates an inadequate moisture level of the soil supporting the foundation system. This situation should be addressed with a watering program in order to prevent damage to the foundation.

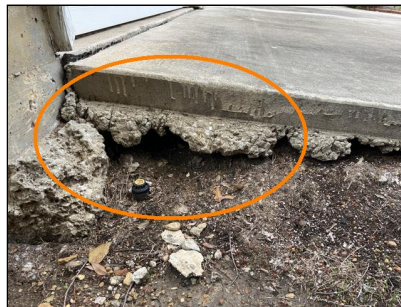
A. Item 7 Driveway, left side (facing front)

(3) I observed soil erosion beneath the driveway. This should be corrected to prevent cracking and settlement of the driveway.

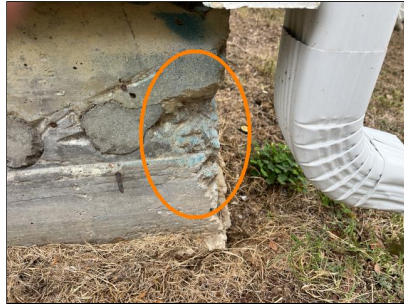
A. Item 8 Corner crack, rear of home

(4) One or more of the foundation corners are cracked / damaged which is commonly referred to as a "corner pop". Although this is cosmetic in nature and not causing any adverse effects to the structure, I recommend having this condition repaired by a qualified professional to reduce the risk of further damage to the grade beam.

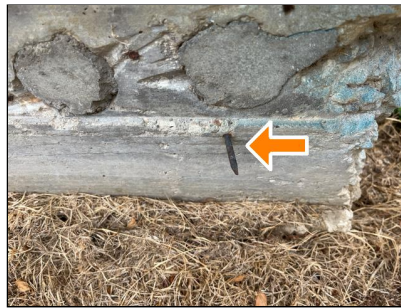
A. Item 10 Rear of home

(5) One or more tension-cable ends are exposed at the foundation. This can cause rust to form. I recommend patching with mortar.

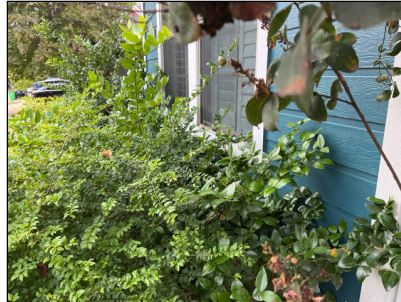
B. Item 3 Vegetation, front of house

(2) The shrubs at the front of the house should be trimmed away from the siding. This can be a source of insect and moisture intrusion if not corrected. It is recommended that a distance of 1 foot is maintained between shrubs and siding.

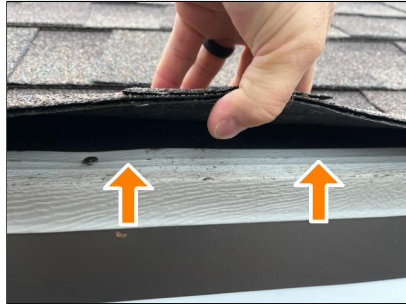
C. Item 1 Improper underlayment on roof

(1) The roof underlayment is installed incorrectly at multiple locations on the roof. At the rakes, the drip edge should overlap the underlayment. At the eaves the underlayment should overlap the drip edge.

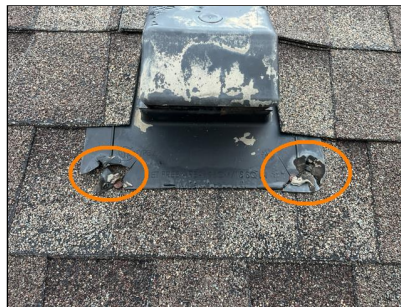
C. Item 3 Dryer exhaust vent flashing

(2) The flashing for the dryer exhaust vent on the roof is damaged and needs replacement. I recommend consulting a qualified roofing contractor for repair.

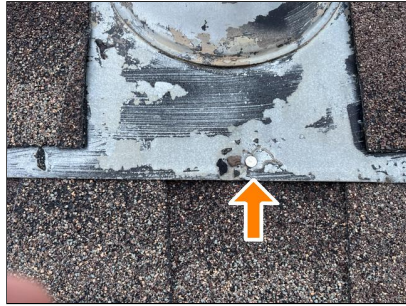
C. Item 4 Exposed nails at flashing

(3) One or more nail heads were exposed. I recommend caulking these to prevent water intrusion.

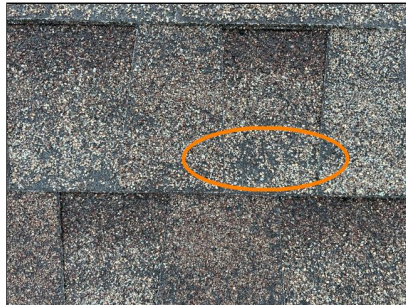
C. Item 7 Wear/delamination

(4) The roof shows signs of wear and delamination in multiple areas. I recommend a roof inspection by a qualified contractor to discuss repair or replacement.

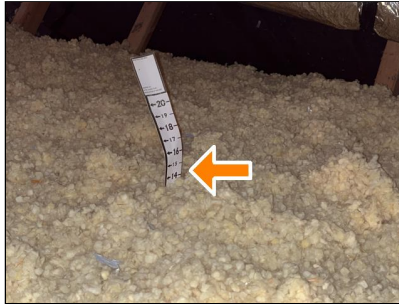
D. Item 4 Loose-fill insulation in attic

(2) The average depth of loose fill attic insulation is 14 inches. This satisfies the minimum recommendation of 10 inches.

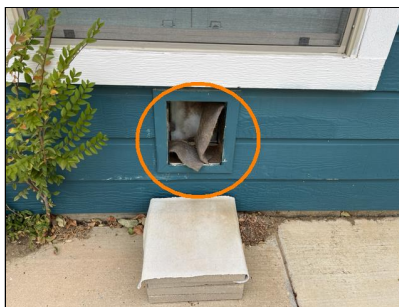
E. Item 1 Pet door, rear of home

(1) There is a pet door located at the rear of the home. The hole is not sealed to prevent water and pest intrusion. I recommend repair as needed.

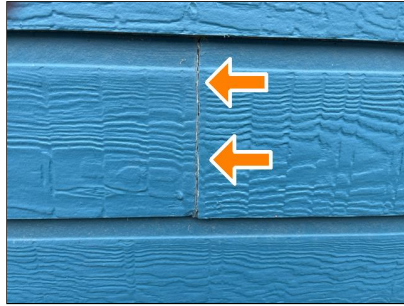
E. Item 2 Seams in siding

(2) There are exposed cracks at the seams of the exterior siding. If not repaired this can lead to water penetration and deterioration. I recommend applying caulk at these areas.

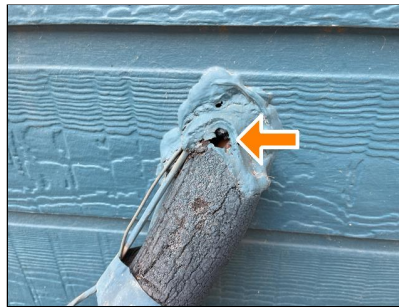
E. Item 4 HVAC line penetration, left side (facing front)

🏠 (3) Pipes penetrating exterior walls left gaps that needed to be sealed with an appropriate sealant to prevent moisture and insect entry. I recommend applying caulk as needed.

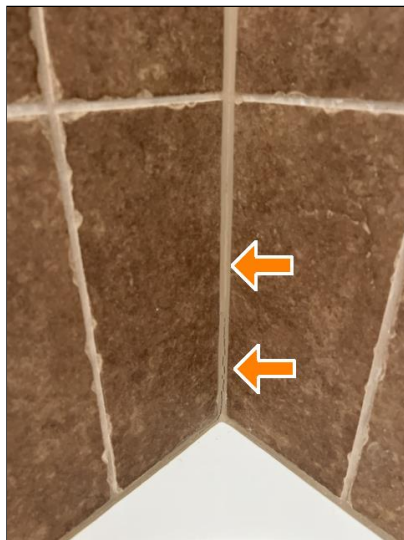
E. Item 5 Hall bathtub

🏠 (4) I observed missing grout in one or more areas on the shower wall in the hall bath. I recommend reapplying grout to prevent water intrusion.

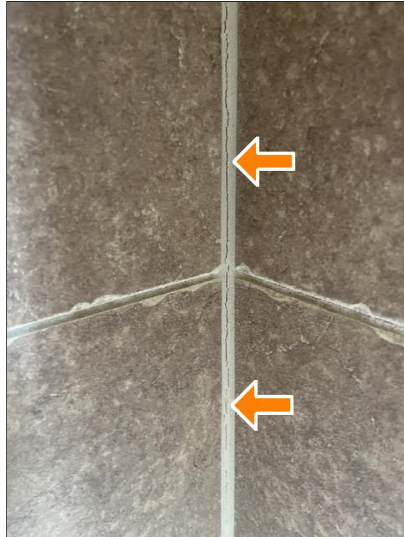
E. Item 7 Master shower

🏠 (5) I observed missing grout in one or more areas on the shower wall in the master shower bath. I recommend reapplying grout to prevent water intrusion.

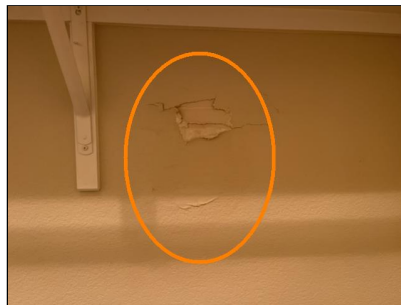
E. Item 10 Wall, utility room

(6) The interior wall is damaged in one or more locations. I recommend repair by a qualified person.

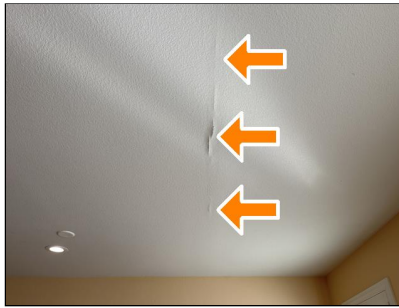
F. Item 1 Ceiling, inside back door

Moderate cracks were observed on the ceiling. This is common in homes in this area of Texas and is often determined to be cosmetic, most often soil settlement. I entered the attic above this area and did not notice any previous moisture damage or repairs. Due to other factors noted during the inspection, I recommend contacting a qualified foundation specialist to determine if action is needed.

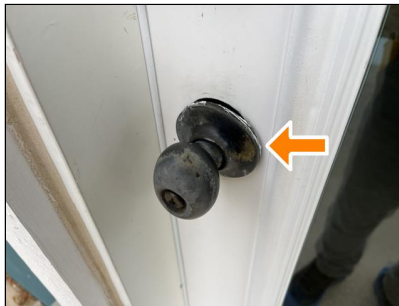
G. Item 1 Doorhandle, rear entry door

(1) The handle is loose on the rear entry door. I recommend repair as needed.

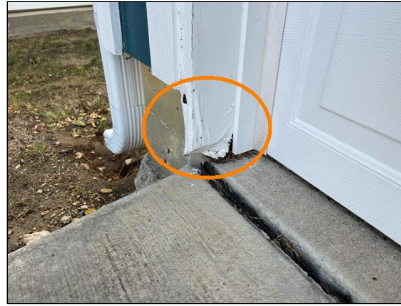
G. Item 2 Garage door, left side

(2) The trim around the garage door showed signs of moisture damage and deterioration. I recommend repair and paint as needed.

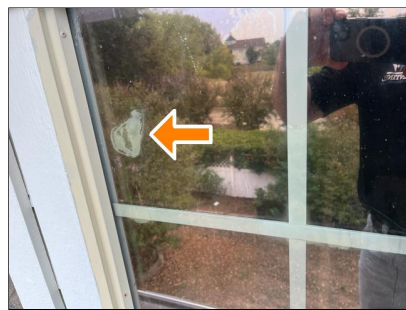
H. Item 1 Window in dormer at rear of home

(1) One or more of the thermal pane windows were observed to have lost their seals. This has resulted in condensation or a fog like film to develop between the panes of glass. The thermal pane windows no longer function as designed when they loose their seal and replacement may be necessary.

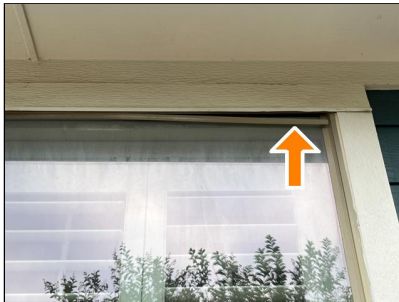
H. Item 3 Window, rear of home

(2) The seal around the glass is damaged and/or deteriorated. I recommend window repair to maintain energy efficiency and avoid further deterioration.

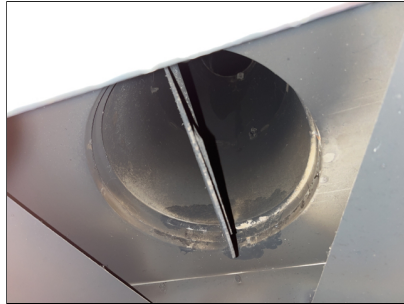
J. Item 2 Fireplace damper

(2) The fireplace damper was missing a damper clamp. When gas is installed in a fireplace with a damper, the damper should be permanently blocked open with a damper clamp to prevent accidental spillage of carbon monoxide into the living space.

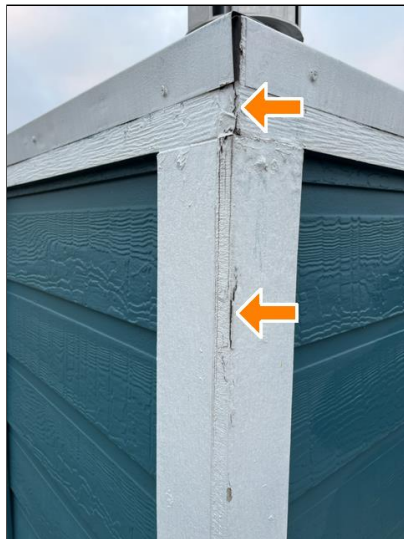
J. Item 5 Wood trim around chimney

(3) I observed mild deterioration of the wood trim around the chimney. I recommend repair and paint as needed.

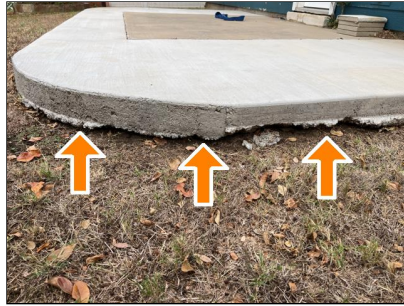
K. Item 1 Soil erosion, back patio

I observe soil erosion beneath the back patio. This can cause settlement and cracking of the concrete. I recommend adding soil.

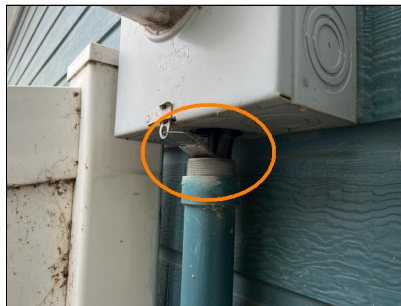
A. Item 1 Conduit at electrical meter

(1) There's a gap between the electrical conduit and the base of the meter. I recommend repair by a licensed electrician so that conduit is properly attached to the meter.

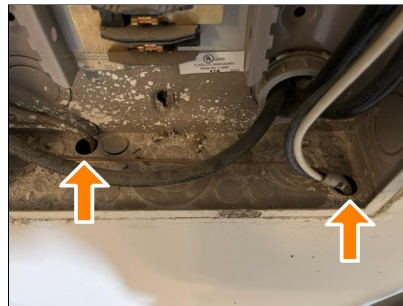
A. Item 4 Service panel, missing grommets

(3) The service panel is missing protective grommets where wires pass through the panel. This can cause damage and wear to the wire over time. I recommend this be corrected by a licensed electrician.

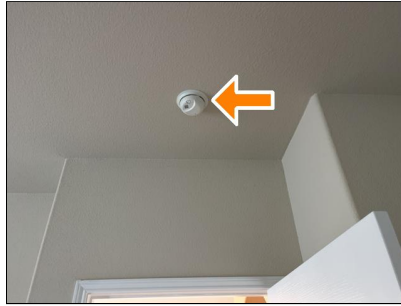
B. Item 1 Smoke detector, master bedroom

(1) At the time of inspection, all smoke detectors were tested. All functioned as intended with the exception of the smoke detector located inside the master bedroom. This may only require replacement of the 9 V battery. I recommend repair/replacement as needed.

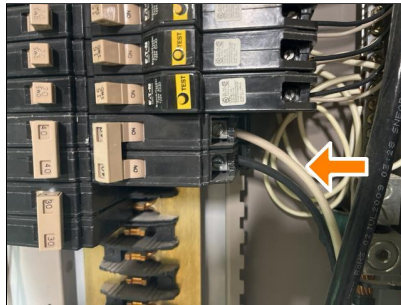
B. Item 2 Improperly-marked wire

🏠 (2) One or more white wires are being used as hot conductors (i.e. they are connected to the breakers) and are not properly color coded. Most times white wires are considered to be neutral conductors. When white wires are used as hot conductors they should be marked with black or red tape/marker to identify them as hot and not neutral.

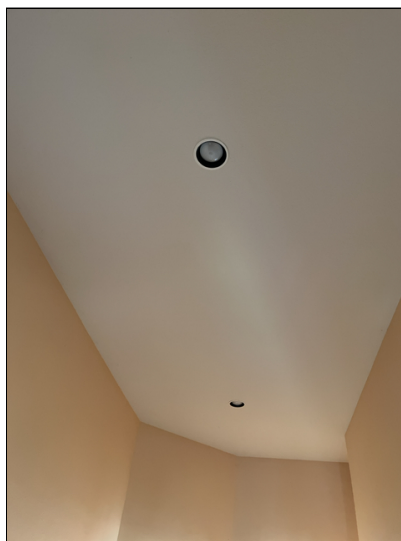
B. Item 3 Ceiling light, entryway

🏠 (3) The light in the entryway did not function as intended. This may only require replacement of the bulb. I recommend further inspection and repair if needed.

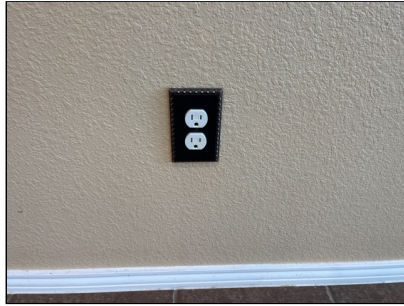
B. Item 4 Loose outlet, breakfast nook

🏠 (4) One or more outlets is loose at the wall. I recommend tightening as needed.

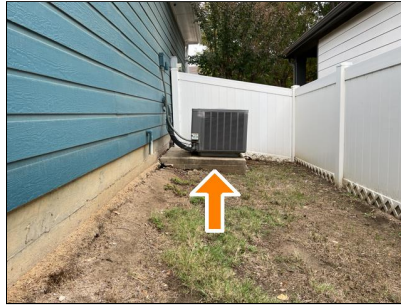
A. Item 3 Concrete pad, condensing unit

(2) The concrete pad for the condensing unit has excessive slope. The slope should not be more than 10°. I recommend repair to make level.

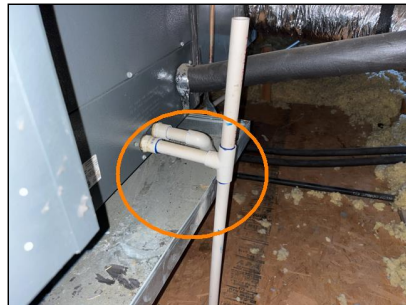
B. Item 1 Condensate drain, HVAC system

🏠 (1) The primary condensate drain to the HVAC system is not installed properly. There should be a P-trap installed where drain exits unit and a vent pipe located after the P-trap. I recommend repair as needed.

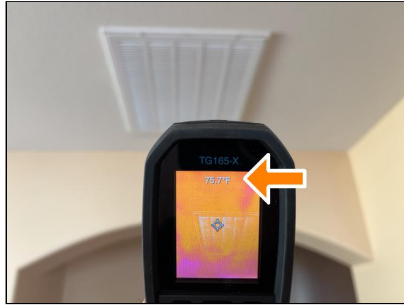
B. Item 4 Temperature reading at air intake on cool setting, 75.7°

🏠 (2) At the time of inspection, the cooling system was operated for 30 minutes prior to taking temperature readings. The differential between the intake and discharge vents should be between 15 and 22°. The readings I obtained indicated a differential of 0°. This would indicate that the HVAC system is not operating as intended. I recommend inspection and repair by a licensed HVAC contractor

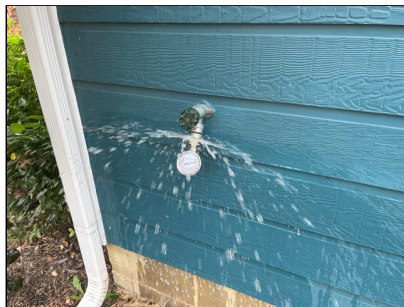
A. Item 1 Hose bib, right side (facing front)

(1) The hose bib at the right side (facing front) and left rear side (facing front) of home leaks when turned on. Repairs are needed. A qualified licensed plumber should repair or correct as needed.

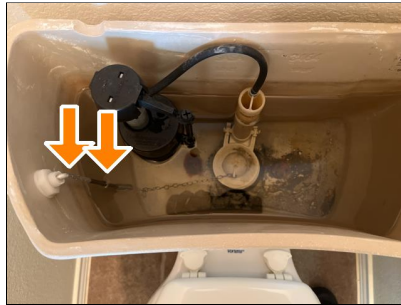
A. Item 5 Handle for flapper valve, master toilet

(4) The handle on the master toilet was improperly installed. The toilet did not flush as intended. I recommend repair by a licensed plumber.

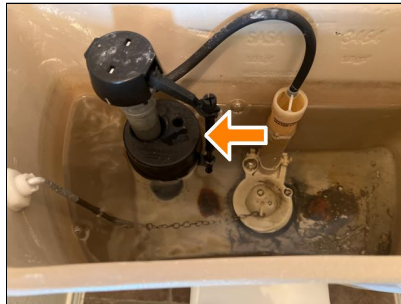
A. Item 6 Float mechanism, master toilet

(5) The float mechanism on the master toilet was not functioning properly at the time of inspection. I recommend repair by a licensed plumber.

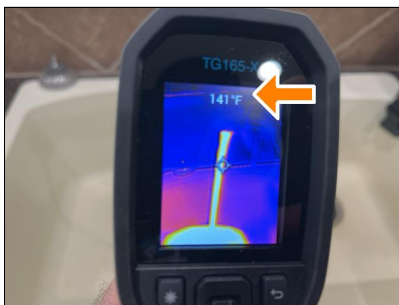
A. Item 8 Temperature of hot water

(7) It is recommended that the temperature setting at the water heater is no more than 120 degrees. The hot water temperature was 141 degrees at the time of inspection. I recommend reducing the water temperature to a safe setting.

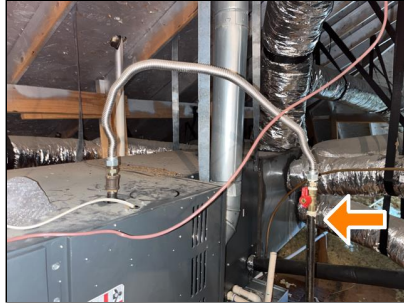
E. Item 2 Gas furnace in attic

(3) A sediment trap is missing on the gas supply line to the furnace. Although it may not have been required when the home was constructed, sediment traps are now required on all new installations.

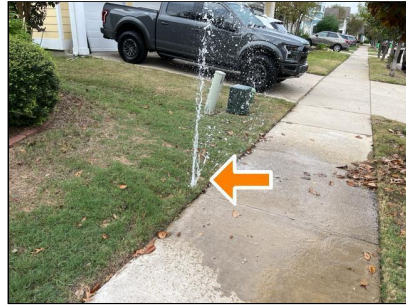
A. Item 3

(2) I observed one or more sprinkler heads that needed repair. I recommend that a licensed sprinkler contractor perform all repairs.
