Inspection Report

Sentinel Home Inspections, LLC

PROPERTY INSPECTION REPORT FORM

11/2/2022
Name of Client	Date of Inspection

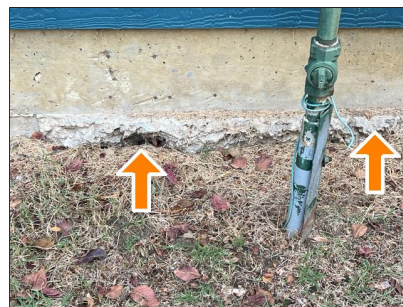
A. Item 2 Perimeter beam, right side (facing front)

(1) Perimeter beam is exposed in one or more areas of foundation. I recommend raising soil level to prevent deterioration and further erosion.

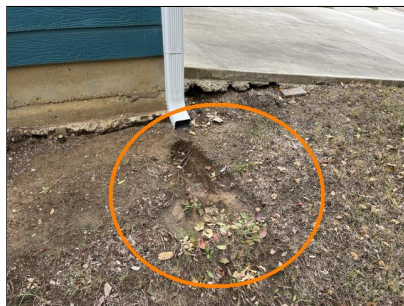
B. Item 1 No splash block and gutter

(1) The downspouts need splash-blocks at one or more locations.

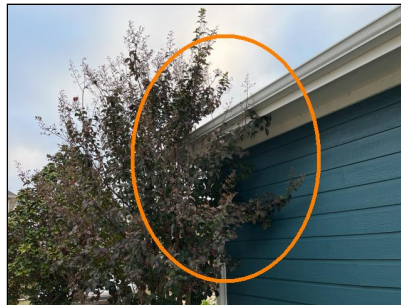
B. Item 4 Tree limbs, right side (facing front)

(3) The tree limbs that are in contact with roof or hanging near roof should be trimmed.

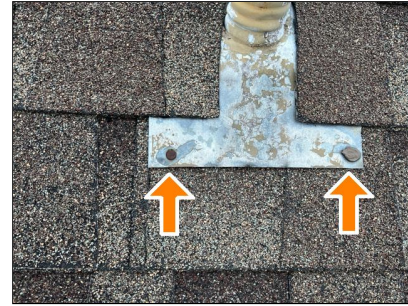
C. Item 5 Exposed nails at flashing

(3) One or more nail heads were exposed. I recommend caulking these to prevent water intrusion.

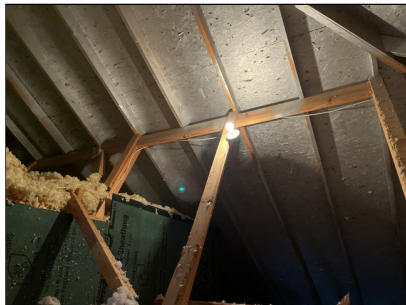
D. Item 1 View of roof structure in attic

(1) I entered the attic and performed a visual inspection. Due to insulation covering the ceiling joists, the lack of permanent flooring, obstructions by the HVAC equipment, and the low clearance of the roof in some areas, many areas of the attic were not visible or readily accessible to inspection.

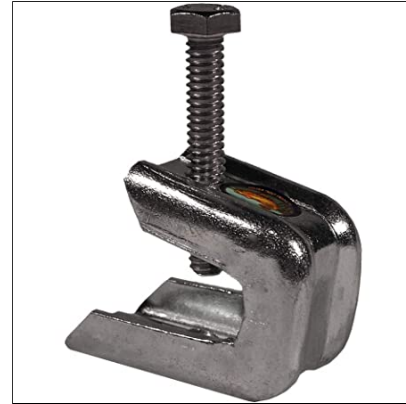
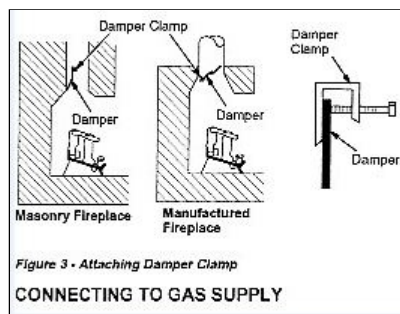
(2) The fireplace damper was missing a damper clamp. When gas is installed in a fireplace with a damper, the damper should be permanently blocked open with a damper clamp to prevent accidental spillage of carbon monoxide into the living space.

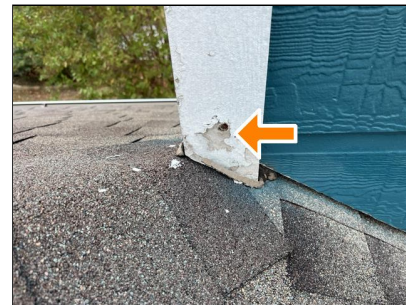
J. Item 6 Wood trim around chimney

(3) I observed mild deterioration of the wood trim around the chimney. I recommend repair and paint as needed.

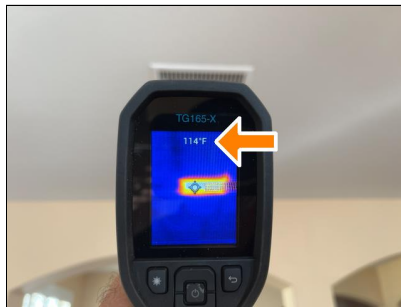
A. Item 4 HVAC temperature and heat mode, 114°

(3) This component appears to be performing adequately at the time of the inspection. It is achieving an operation, function, or configuration consistent with accepted industry practices for its age. All three units were heating between 110-130 degrees.

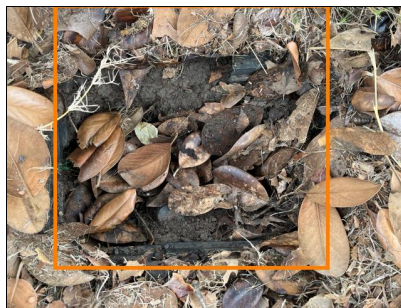
A. Item 3 Water meter, next street

(2) At the time of inspection, there was excessive debris in the water meter box.

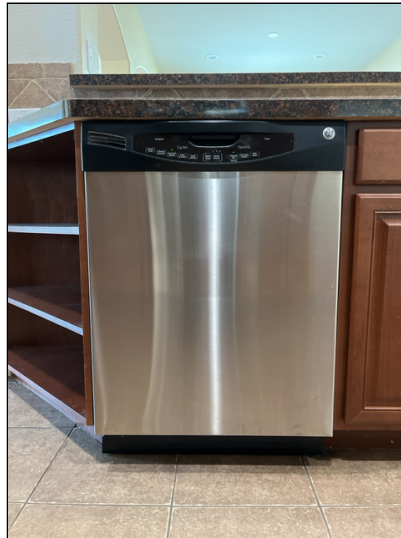
A. Item 1 Dishwasher

The dishwasher was tested by running a "Normal" cycle. The unit responded to controls and appears to be operating properly at the time of inspection.

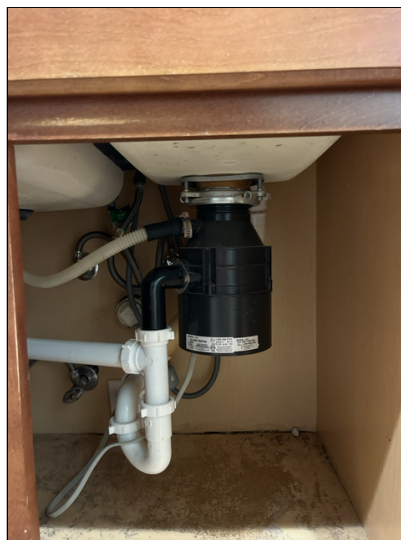
B. Item 1 Garbage disposal

The disposer responded to controls and appears to be operating properly at the time of the inspection. I did not observe any excessive noise or vibration nor any leaks or damage to the unit at this time.

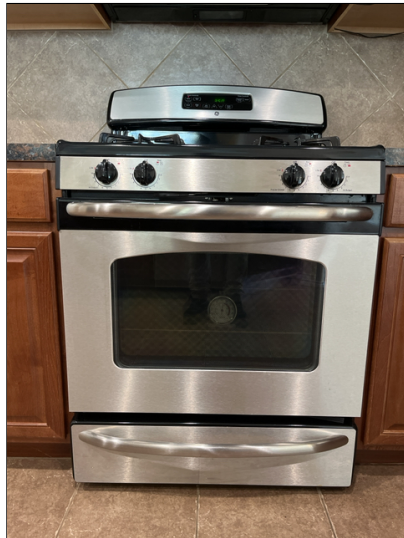
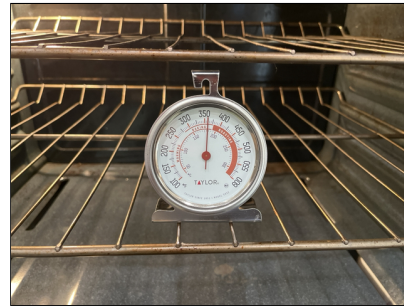
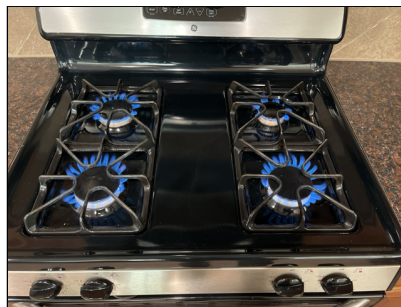
The oven and the cooktop are gas. All cooktop burners/elements are operating as intended. The temperature inside the oven was approximately 355 degrees 30 minutes after setting the temperatures on 350 degrees on "Bake". The acceptable range is 325-375 degrees. The cooktop and ovens appear to be operating as intended at the time of the inspection.

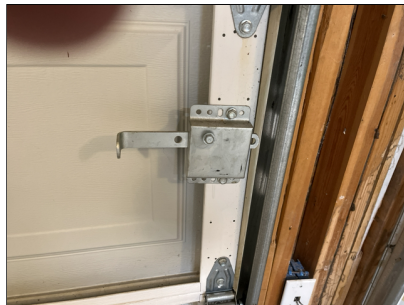
H. Item 1 Garage door, manual locking mechanism

(2) When a automatic door opener is used, the manual door latch/lock should be disabled or removed.

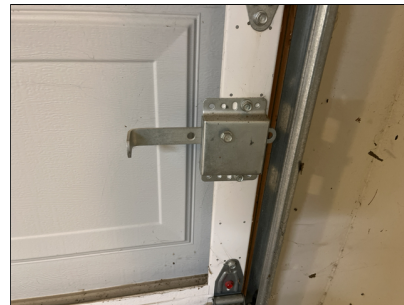
H. Item 2 Garage door, manual locking mechanism

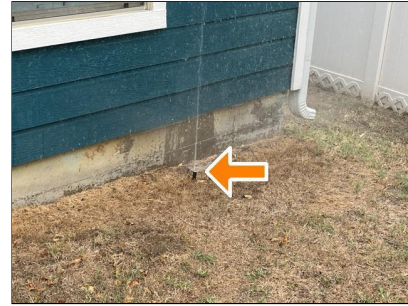
A. Item 4

(2) I observed one or more sprinkler heads that needed repair. I recommend that a licensed sprinkler contractor perform all repairs.

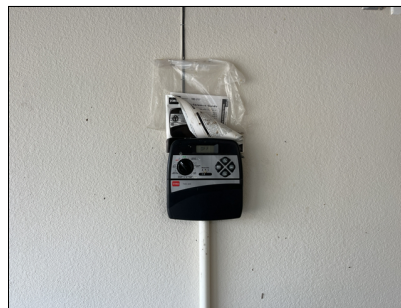
B. Item 1 Sprinkler controller, garage
